**Full Non-Invasive Moisture Test Inspection On  
123 Anywhere Street, Auckland**

**Date of inspection:**..... 9<sup>th</sup> October 2007  
**Weather conditions:** ..... Dry  
**Previous Weather conditions:** ..... Variable  
**Compass bearing from official front door:**..... South facing

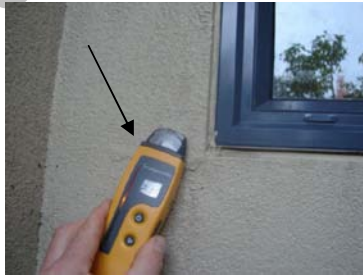
Readings to isolated areas here escalated to 21% ('Search Mode') indicating the possibility of moisture within the solid plaster to a local area.

Right – 'Search Mode' readings here suggest moisture ingress penetrating beyond the paint line local to a visible crack. Attention is required.

Professionally applied paint suitable quality sealant to all vertical window and door joinery details is recommended prior to the next repaint.

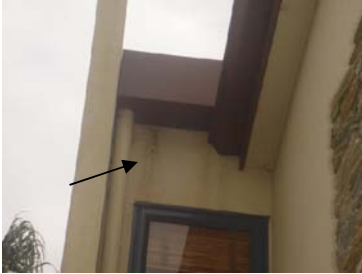
Evidence to suggest excessive water flows beneath the rain head is visible here.

Repositioning the rain head to accommodate a 50mm minimum clearance from the cladding is recommended. This will enable flashing and sealing the plaster surface beneath and allow any future overflow (if any) to harmlessly disperse away from the building line.

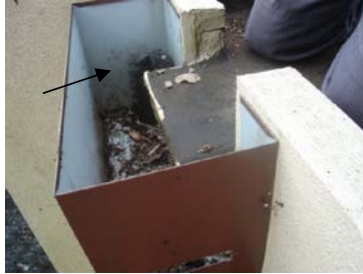
Bristle foliage protector should be removed or cleaned regularly.

It is believed that the moisture ingress concerns detected in the office area wall linings local to the rain head are as a direct result of rain head design defect. The bristle foliage protector has been inserted into the down pipe outlet within the rain head box. This is causing a back-up of collected water which is currently over loading the local spouting configuration. The foliage protector should be removed or cleaned at regular intervals.

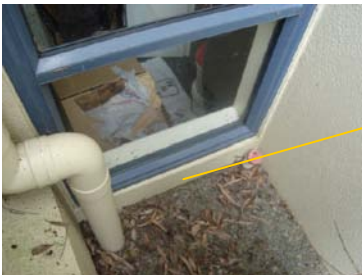
The finished concrete path height has compromised the ground clearance here.

The concrete pathway is creating a breach to ground clearance beneath the garage south-east elevation window.

Forming a drainage channel here to allow collected water to disperse into the local storm water drainage system whilst artificially creating ground clearance to the base of the channel is recommended.

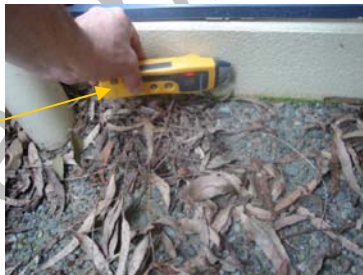
'Search Mode' readings were high. Moisture ingress due to the ground clearance breach is suspected.

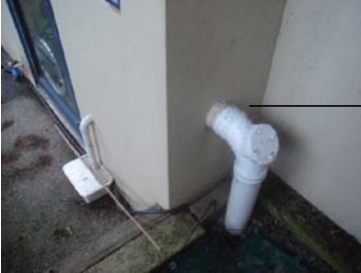
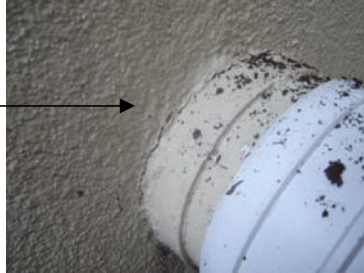
Further testing to areas directly around fixings penetrating the cladding system was performed. Although no moisture concerns were detected, it should be noted that the cracks to the sealant provisions around the soil pipe penetration at the rear north-east elevation of the laundry are present.

Sealing the soil pipe penetration is required.

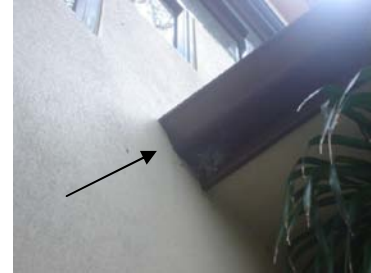
Spouting butted against the cladding prevents paint application to cladding beneath. Clearance is recommended.

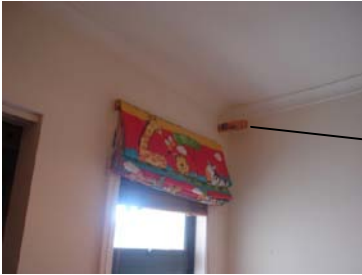
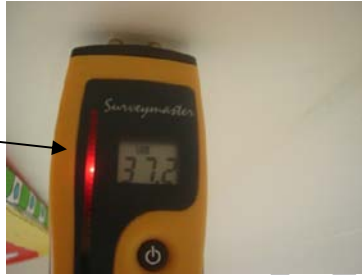
- The plasterboard wall lining over the south-east window in the office exterior wall directly beneath the rain head gave readings of **21.3 - 37.2%**.

**37.2%** is high.

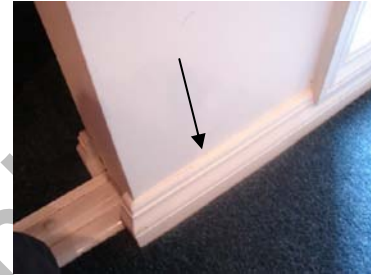
Suspected moisture signatures in the skirting trim beside the window beneath the rain head are visible. 'Measure Mode' moisture testing proved inconclusive.

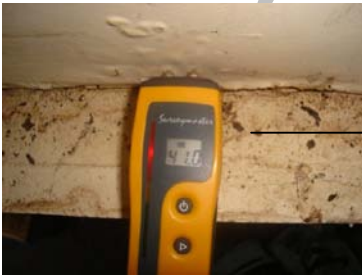
- Further moisture is present in the plasterboard wall lining local to the exterior findings at ground level beneath the rain head beside the garage. 'Measure Mode' short probe testing detected levels of concentration between **33.4 - 41%**.

**41%** is high.

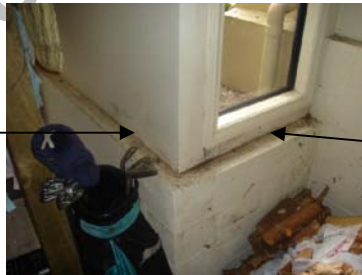
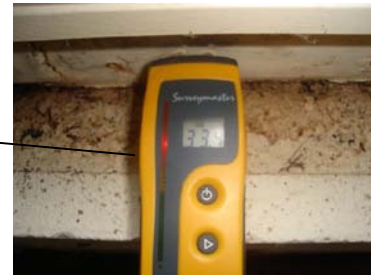
**33.4%** is high.

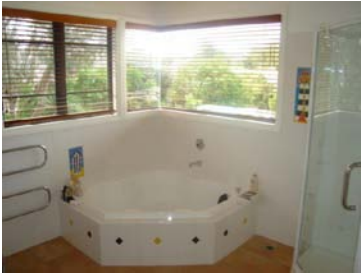
- Isolated minor sealant failure to the shower cubicle in the main bathroom is noted. Although moisture levels locally around the wall linings and flooring substrate are acceptable, leaks are present under test conditions.

Right – Minor leaks were sighted under test conditions. Attention is required.
